## Dymet Case Studies: Marine Industry

### Prevention of Frictional Seizure of Propeller Bolts

### Repair of Cast Iron Engines

### Urgent Repair of Metal Equipment and Tools

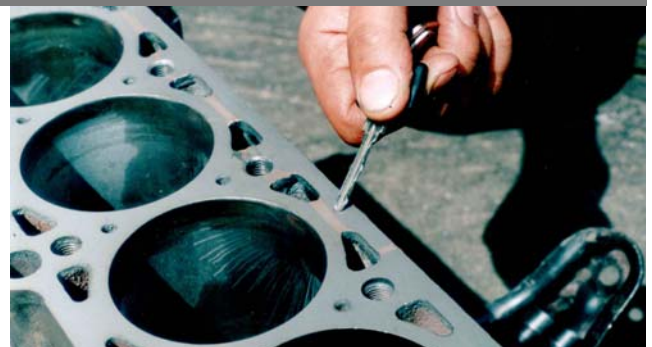
The upper layer was coated with copper. The polished surface looks perfect. After repair the vehicle is working now for more than a year.

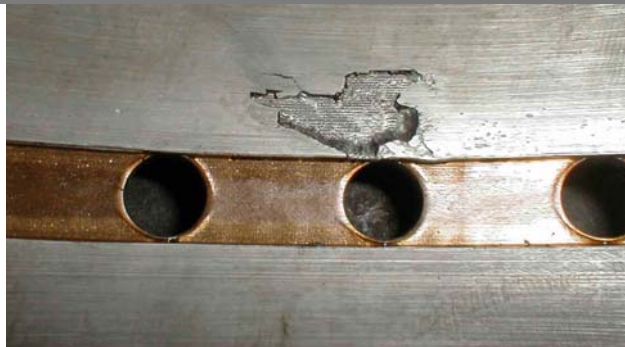
A sliding bearing had a damaged surface of about 2 cm wide. The detached coating is removed and the defect edges are smoothed. The surface of the defect and the surrounding area are sandblasted with Dymet.

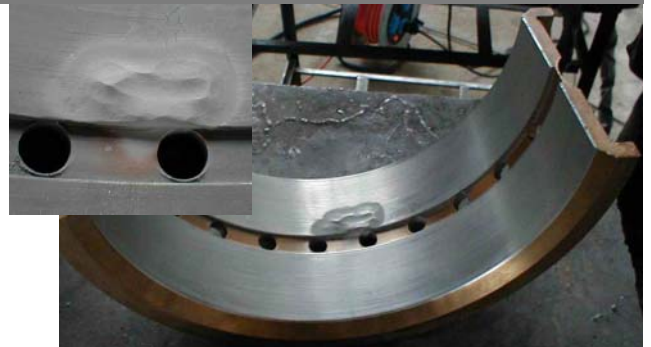
The treated area is sprayed over with babbit powder. A specially designed nozzle is used in this case. An excessive metal volume is created instead of a damaged layer. It is now only needed to turn the bearing to the required dimensions.
