Dymet Case Studies: Oil and Gas Industry

Thread Protection of Drilling Pipes

Clearance Restoration in Gas Turbine Compressors

Repair Of Power Cylinder Components Of Gas-Engine Compressor

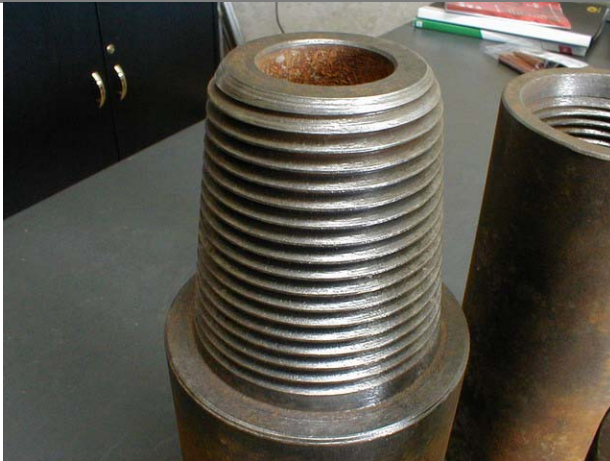
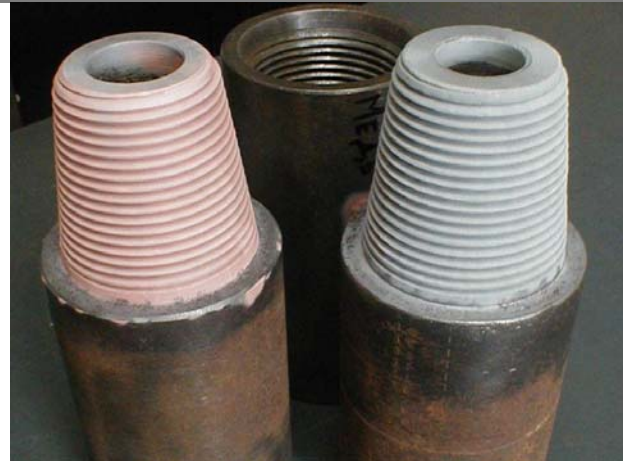
A typical life of the oil-well tubing is about 10 round-trips. The major cause of the oil-well tubing failure is lack or loss of the thread tightness (hermeticity) due to its damage and caving at the points of maximum loading.

Score –resistant coatings of ductile metals can significantly reduce frictional seizure of the joining elements and prevent stress cracking.

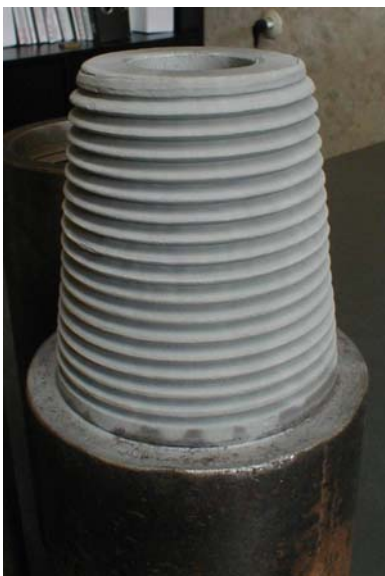
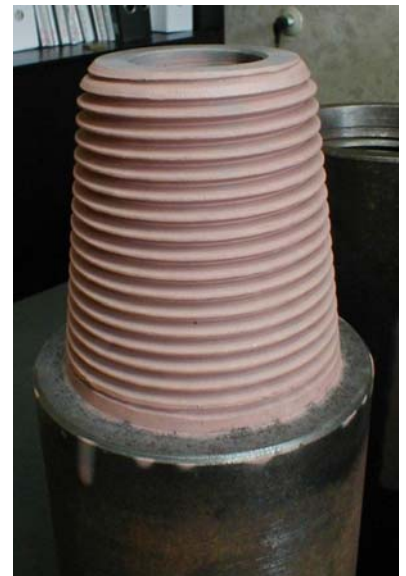
The thread of drilling pipes can be easily sprayed with Dymet even in the field conditions.

Zinc and copper powders or their combination can be used as soft / ductile metals. It is sufficient to spray coating on the most loaded side of the thread.

The coatings can be applied multiple times as required to ensure the tightness of the thread.

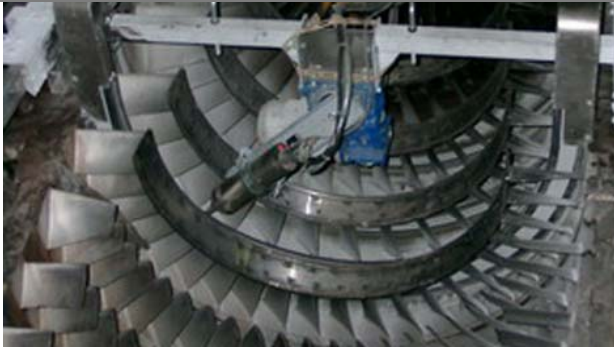
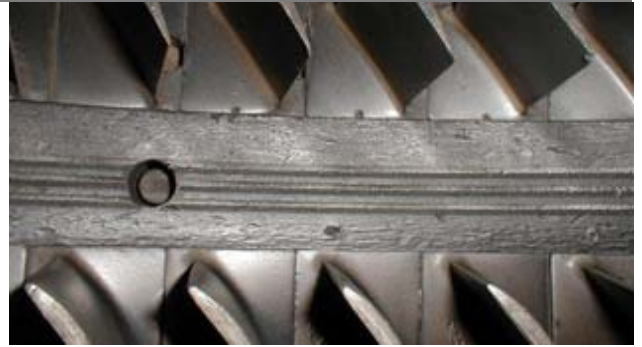
The radial clearance on the stators of axial-flow gas-turbine compressor can be restored by depositing an aluminium coating. It can be done in semi-automatic mode in a special rig.

After 6700 hours the required clearance is still maintained. The stator material is cast iron, coating – aluminium.

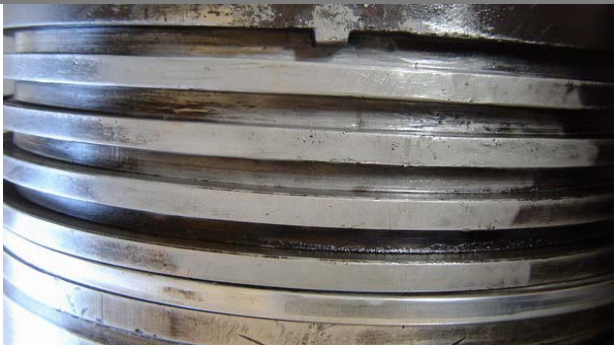
Plunger of power cylinder (D=435mm) had microcracks and worn volume. It was restored with Dymet and grinded. Then a nickel coating was deposited to level the surface, reduce thermal stresses and protect the repaired areas.

- The seats of eight gas separators were restored with aluminium powder. It could not be done by welding due to presence of gas.
- The defects of three aluminium inserts in turbine compressor were repaired
- 14 inserts of connecting rod were sprayed with babbitt powder and machined. Worked for 2500 hours without failure.
- Plunger and bush of power cylinder (D=435mm) were fixed with nickel powder and showed good results

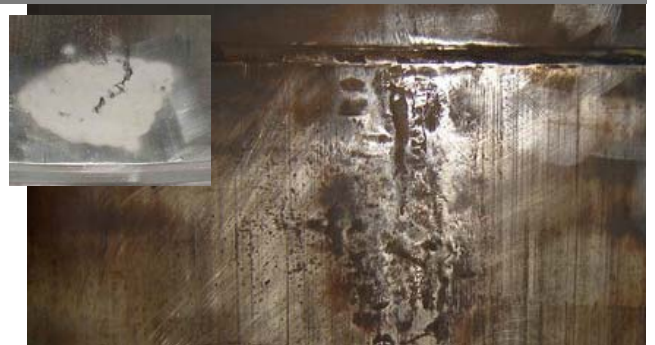
Bush of power cylinder (D=435mm) had a burn-out crack. After abrasive blasting a nickel coating was deposited and then machined to the required size. By now the bush has worked 2500 hours without failure
